Building Inspectors of WNY 7011 Bear Ridge Road Pendleton, NY 14120 Building Inspection Report

123 Any Street, Buffalo NY

11/23/19, 9:15 AM

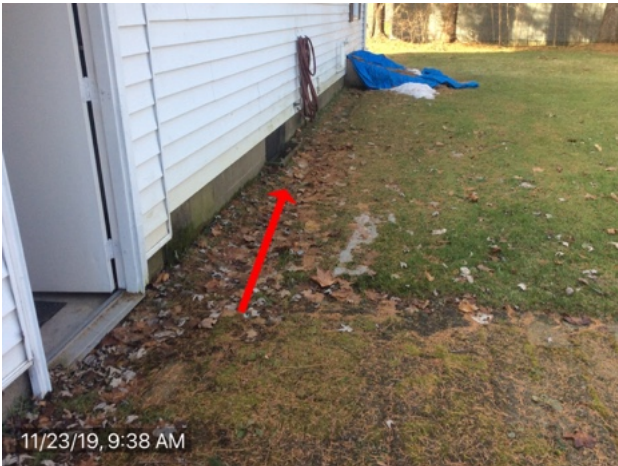
Appendix 1

Question	Response	Details
Grounds		Score (9/13) 69.23%
Does the Property Have Walkways?	Yes	
Walkway Type	Concrete	
Condition	Satisfactory	
Does the Property have a Driveway?	Yes	
Driveway Type	Concrete	
Condition	Satisfactory	
Does the Property Have a Patio?	No	
Does Property have a Porch	No	
Does the Property have a Deck	No	
Slope and Drainage around Building	Poor	Ground slopes towards rear basement wall. Add galvanized window wells and re-grade to slope away. Basement walls have water stains from poor rear yard drainage.
<div>

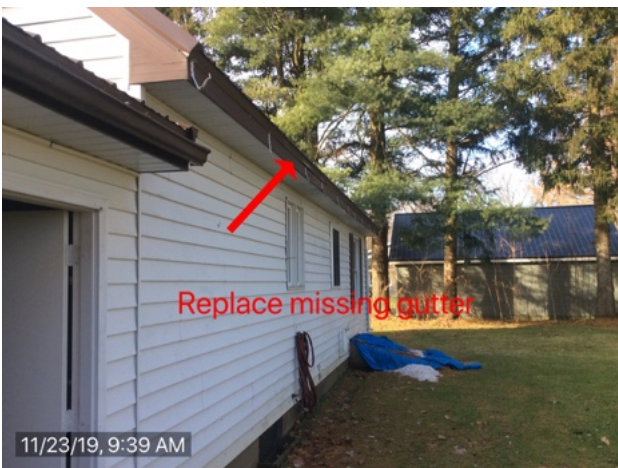
Appendix 3

Question	Response	Details
Condition	Poor	Replace missing gutters and downspouts and pipe drains away from foundation to improve drainage.

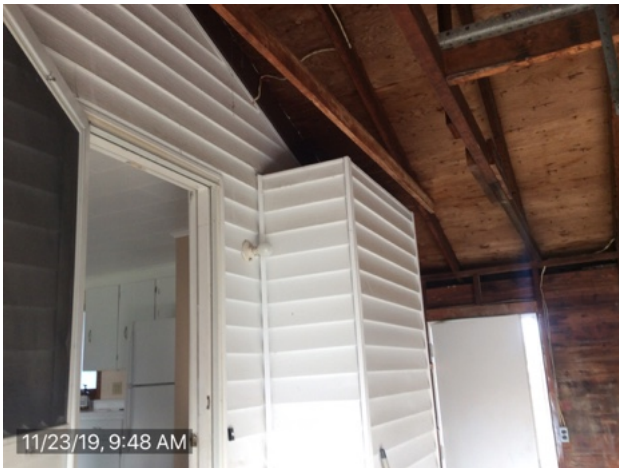
Appendix 5

Question	Response	Details
Door Type	Wood, W/Storms	
Condition	Fair	Consider replacing with metal insulated door.
  <p>Appendix 4</p>		
Patio Door/s	No	
Windows		
Window		
Window 1		
Type Material	Vinyl	
Window Type	Casement, Double Hung, Insulated Glass	Kitchen has original wood casement window. Consider replacing with vinyl unit.
Window Location	All	
Condition	Satisfactory	
Storms and Screens	Yes	
Type Material	Screens Only	
Condition	Satisfactory	
Exterior Section Notes		
Garage <div>Score (22/29) 75.86%</div>		
Does Property have a Garage	Yes	
Garage		
Garage 1

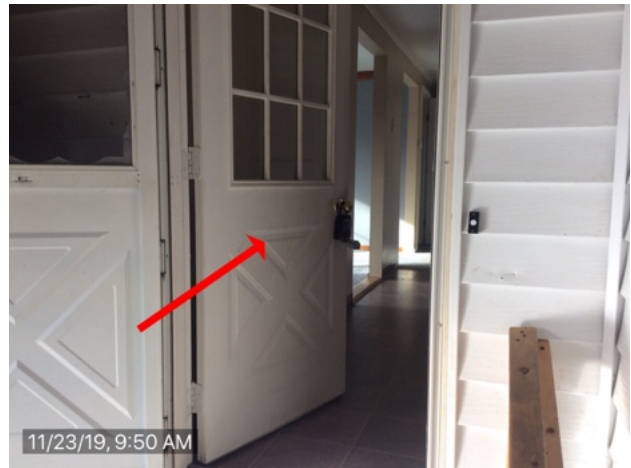
Appendix 6

Question	Response	Details
Garage Attached or Detached	Attached	
Foundation	Block	
Condition	Satisfactory	
Floor	Concrete	
Condition	Satisfactory	
Plumbing	Yes	
Plumbing Equipment	Floor Drain	
Condition	Not Applicable	
Walls	Frame	
Condition	Satisfactory	
Fire Coating at House (Wall/Ceiling)	No	Should be drywall fire wall at house garage area. Garage was added after house was built.

Question	Response	Details
Is the Door Fire Rated?	No	Consider metal fire door for house entrance door.

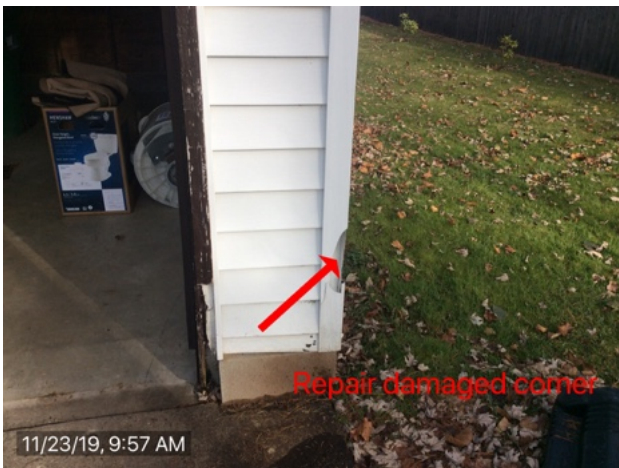
Appendix 7

<p>Appendix 6</p>		
Condition	Fair	
Stairs to House	Yes	
Railing	Yes	
Condition	Fair	Stairs are loose secure to floor.
Roof Structure	Gable, 2x6 24" Centers	Roof ridge has minor bowing.
Condition	Satisfactory	
Siding	Vinyl Siding	
Condition	Fair

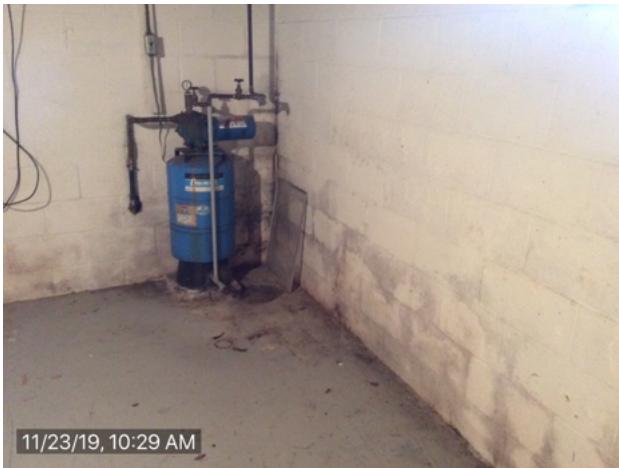
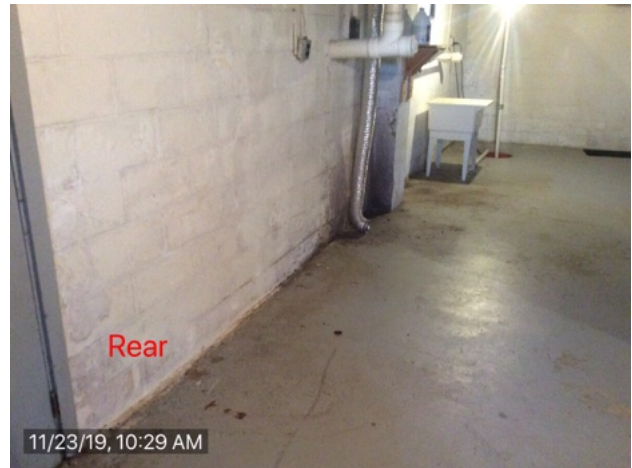
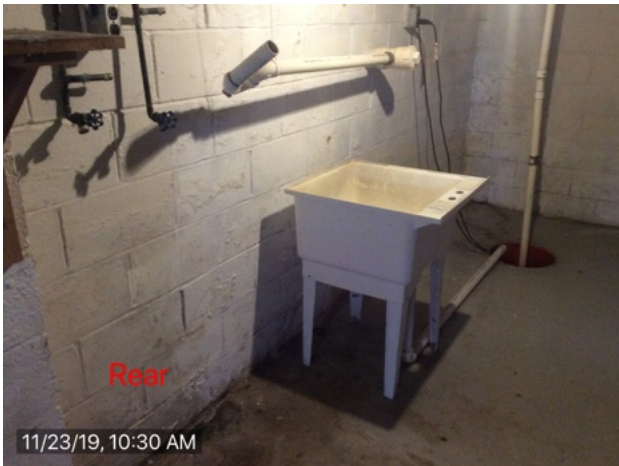
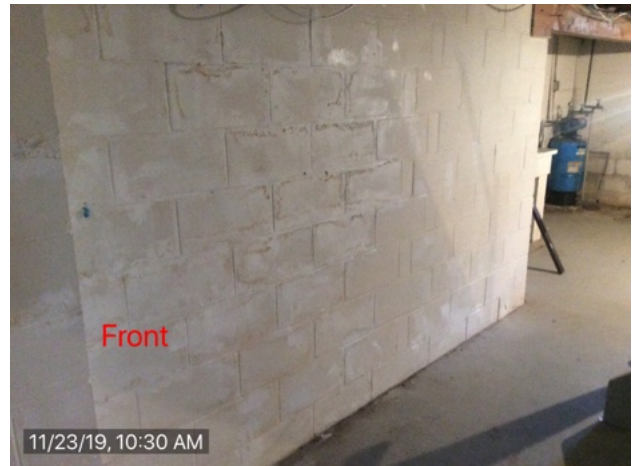
Question	Response	Details
What type of water signs	Stains	Wall seepage from poor exterior drainage. Improve exterior drainage.
<div>

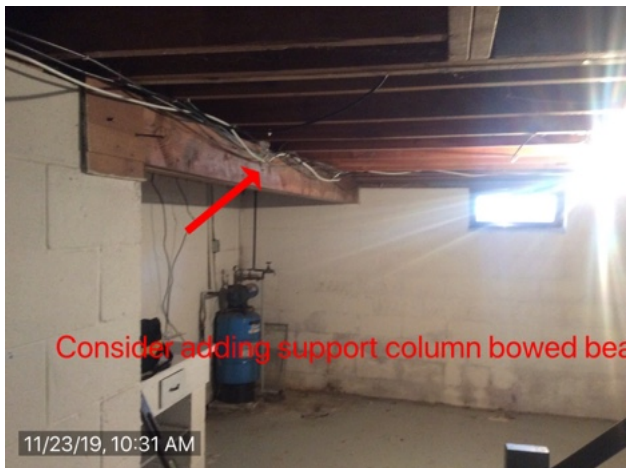
Appendix 17

</div> <div> Appendix 13 Appendix 14 Appendix 15 Appendix 16 </div>		
Any sign of Water on Floor	Yes	
What type of water signs	Stains	
Basement Have Insulation	N/A	
Floor Joists	2x8 16" o.c.	
Bridging	Yes	
Level	Yes	
Condition	Satisfactory	
Support Column(s)	4" Pipe	
Plumb	Yes	
Condition	Satisfactory	
Main Beam	Wood	
Size of Beam	8"	
Level	No	
<div>

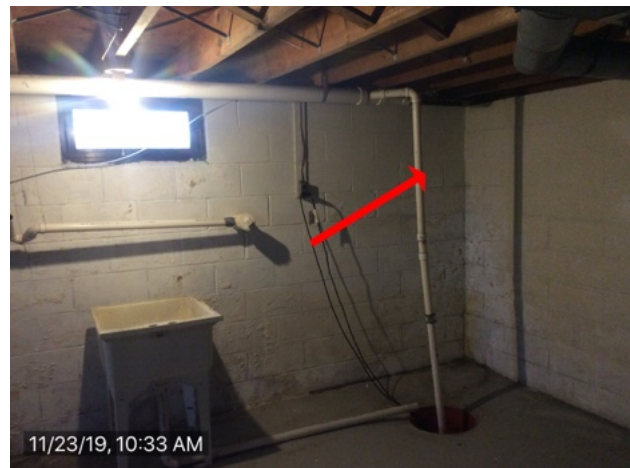
Appendix 18

Question	Response	Details
Condition	Satisfactory	
Interior Structural Components Notes	Reinforcing of side yard Basement wall may be required in near future.	
Plumbing		Score (9/20) 45%
Sump Pump	Yes	
Type of Pump	Sump Pump Submersible	
Backup	No	
Sump Pump Discharged	Sewer	
Condition	Poor	Re-pipe sump discharge to side yard and disconnect from septic system.
<div>

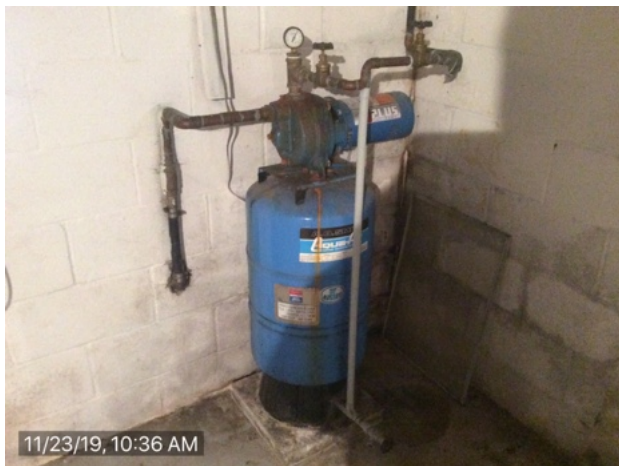
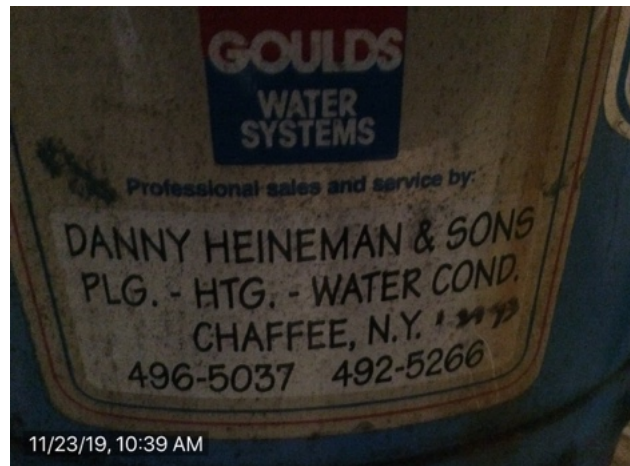
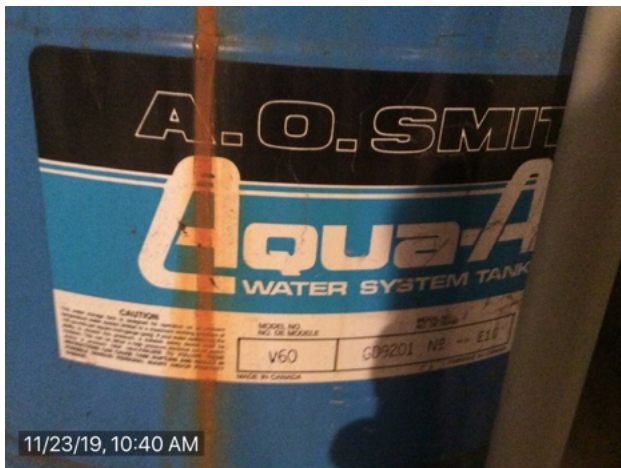
Question	Response	Details
Condition	Fair	Pump runs continuous when faucets are on. Consider adding a system with a Reserve tank so pump does not run continuous. Consider adding water treatment system. Well was not part of the inspection.
<div><div>

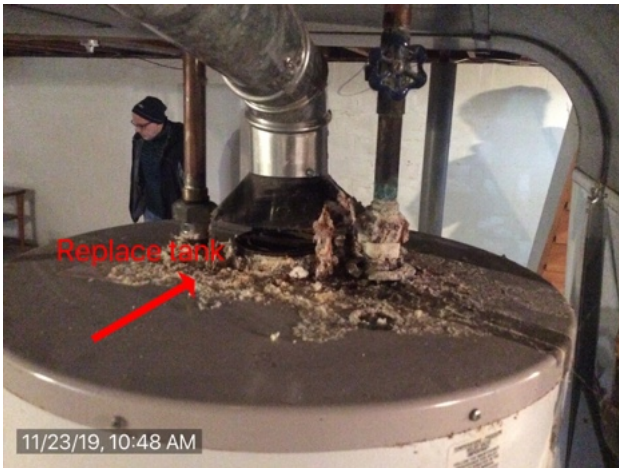
Appendix 25

Question	Response	Details
Brand	GE	
Model#	Photo	
Serial Number#	Photo	
Size	50	
Age	15	
Water Heater Temp/Pressure Relief Valve	Yes	
Extension Pipe	Yes	
Condition	Poor	Tank is in need of replacing.
Water Heater Vent Pipe	Sheet Metal Direct	
Condition	Poor

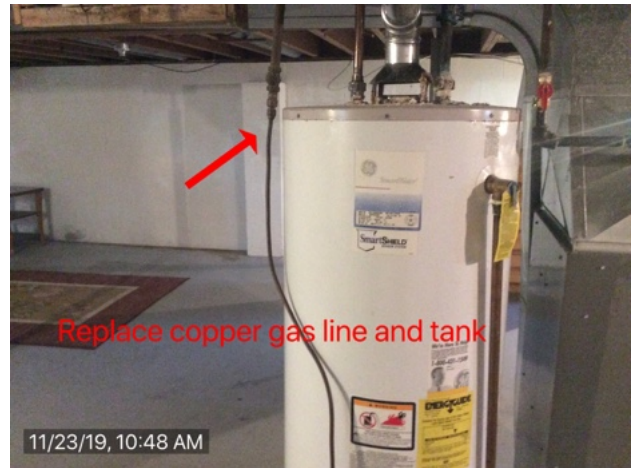
Appendix 26

<p>Appendix 25</p>		
Fuel Pipe	Copper	
Drip Leg	Yes	
Shut Off valve	Yes	
Condition	Poor

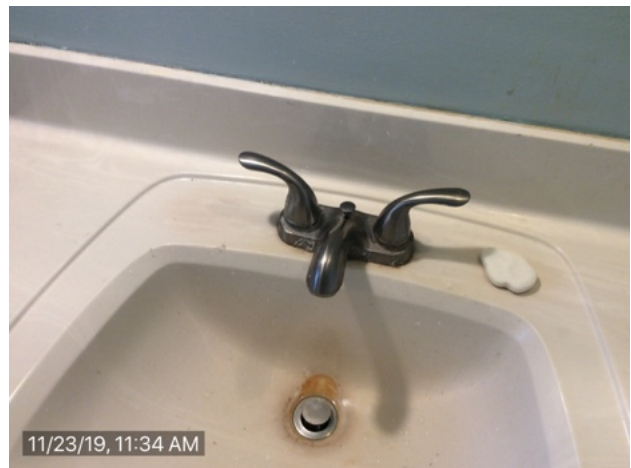
Appendix 32

Question	Response	Details
Bathroom		
Bathroom		
Bathroom 1		
Location	Lower	
Type of Door	Hollow Door	
Condition	Satisfactory	
Type of Windows	Insulated	
Condition	Satisfactory	
Ceiling	Paint	
Condition	Satisfactory	
Flooring	Vinyl	
Condition	Satisfactory	
Walls	Paint	
Condition	Satisfactory	
Exhaust Fan	Fan	
Condition	Satisfactory	
Tub Condition	Satisfactory	
Shower Condition	Satisfactory	
Toilet Condition	Satisfactory	
Fixture Conditions	Poor	Replace sink faucet
  <p>Appendix 32</p>

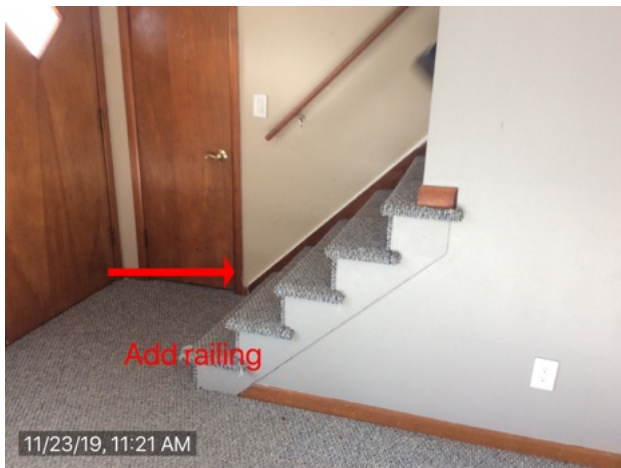
Appendix 33

Question	Response	Details
Dishwasher	No	
Exhaust Fan		
Appliance Section Notes		
Hall Stairs		Score (2/3) 66.67%
Does House Have Multiple Floors	Yes	
Hand Railing	Yes	Add railing to lower hall.
<div>

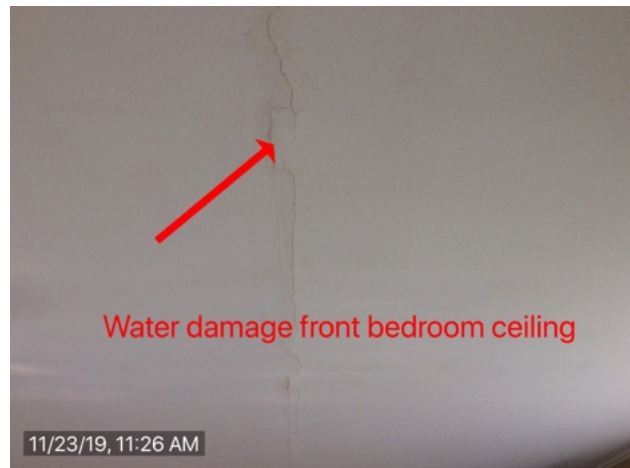
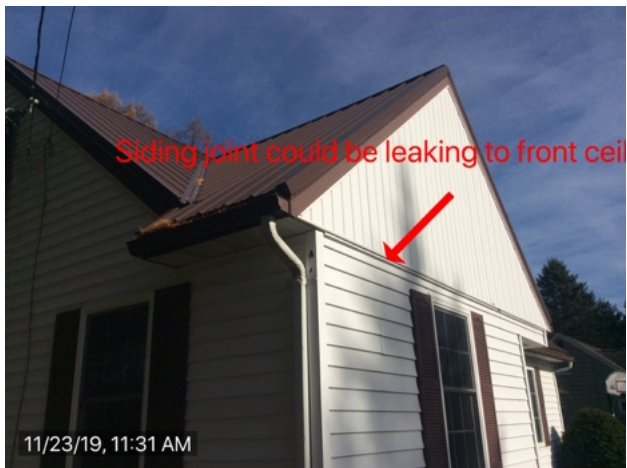
Question	Response	Details
Walls	Paint	
Condition	Satisfactory	
Fireplace	No	
Electrical	Grounded	
Room Notes		
Family Room		
Family Room	No	
Other Room		Score (7/10) 70%
Other Room	Yes	
Other Room		
Other Room 1		
Location	Lower bedrooms	
Type of Door	Hollow Door	
Condition	Satisfactory	
Type of Windows	Insulated	
Condition	Satisfactory	
Ceiling	Paint	
Condition	Poor	Active ceiling leak. Further investigate during driving rain. Suspect front siding may be leaking at J channel. Make repairs as required.
<div><div> <p>Appendix 34</p></div><div>
