## BUILDING INSPECTORS OF WNY, INC.

**Re: Commercial Building Inspection**

## BUILDING INSPECTION REPORT

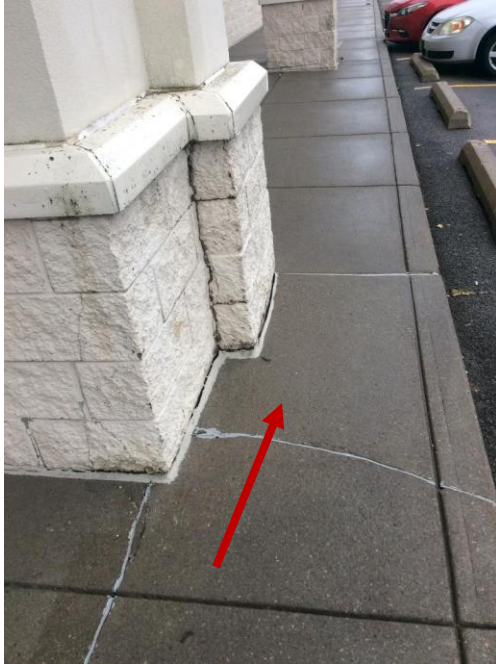
**Shows side concrete walk cracked and settled from water running off building roof gutter.  
Replace sidewalk as required.**

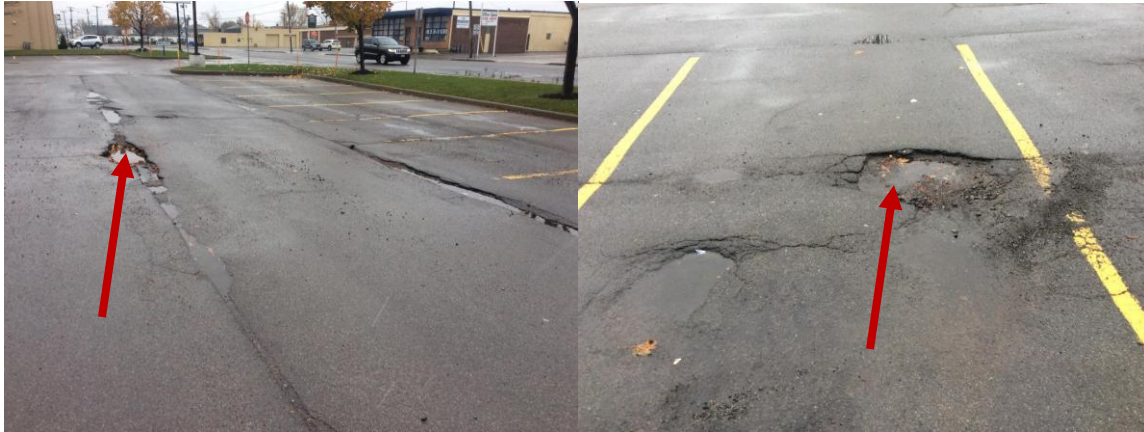
**Parking and driveway have not been maintained. Large pot holes exist that are tripping hazards, repair as required for safety.**

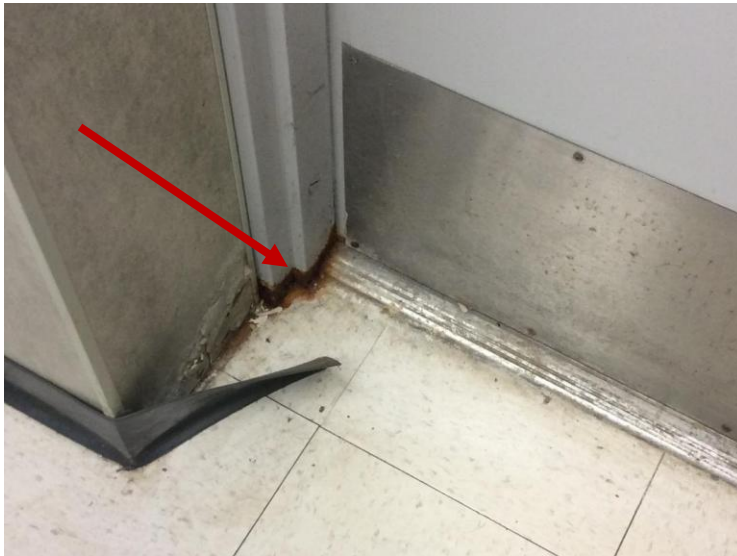
Side entrance metal door frames are rotted at the bases, consider replacing in near future.

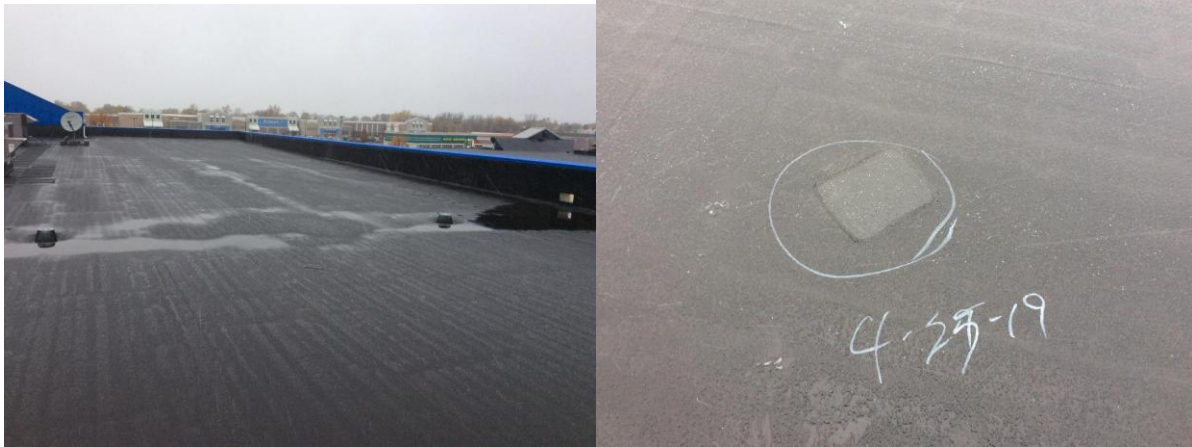
**COMMENTS: Roof has had approximately 25 repairs., appears to be the original rubber roof membrane which would be approximately 19 years old. Roof is nearing the end of its useful life plan on replacing in the near future. Roof had active leaks during the inspection with buckets placed on the main store floor to collect dripping water.. Ball Park for replacement costs range from \$4.00 to \$7.00 per SF. Budget \$60,000 to \$80,000 for new rubber membrane roof.**

**Shows roofing repairs that are dated accordingly.**

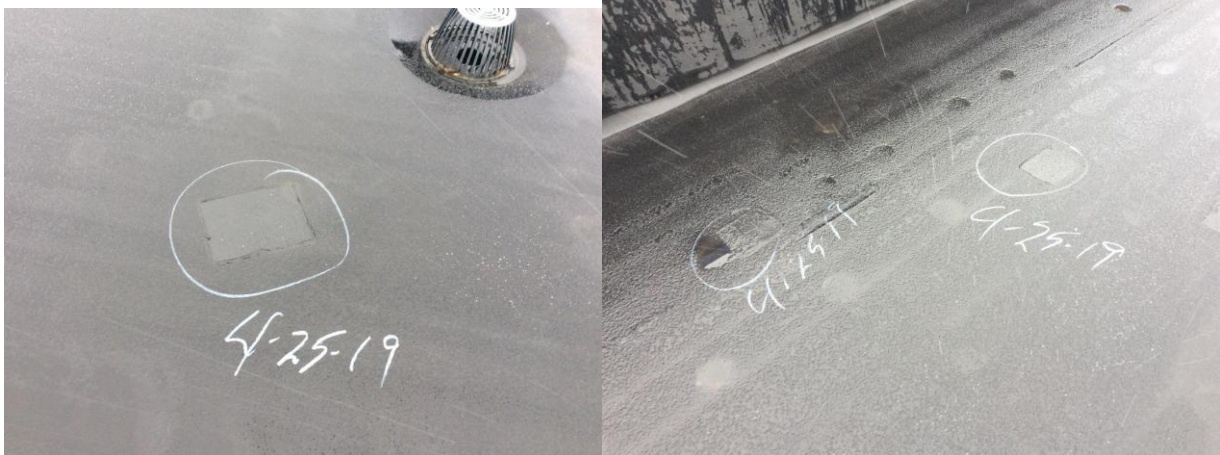
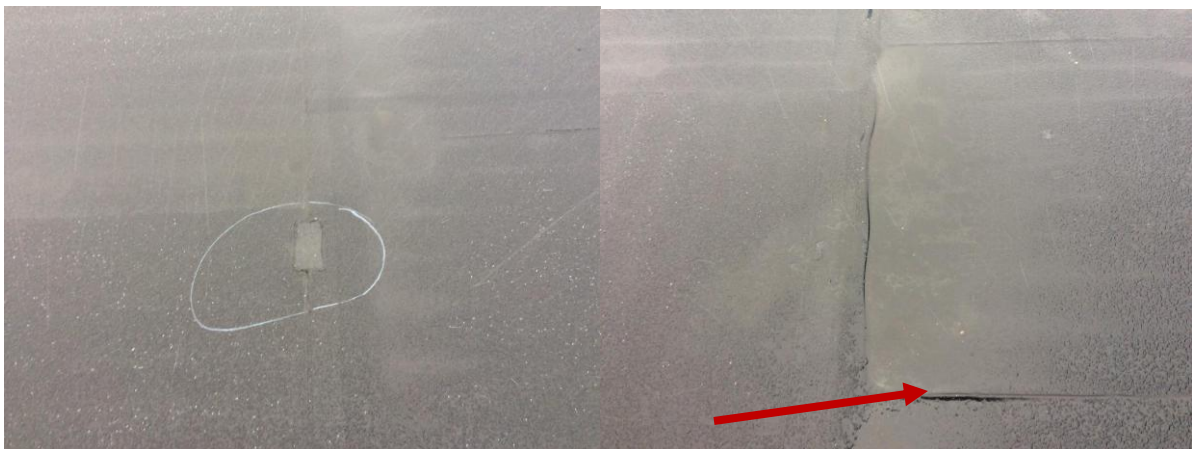
**Shows roof repairs and also shows lifting rubber seams.**

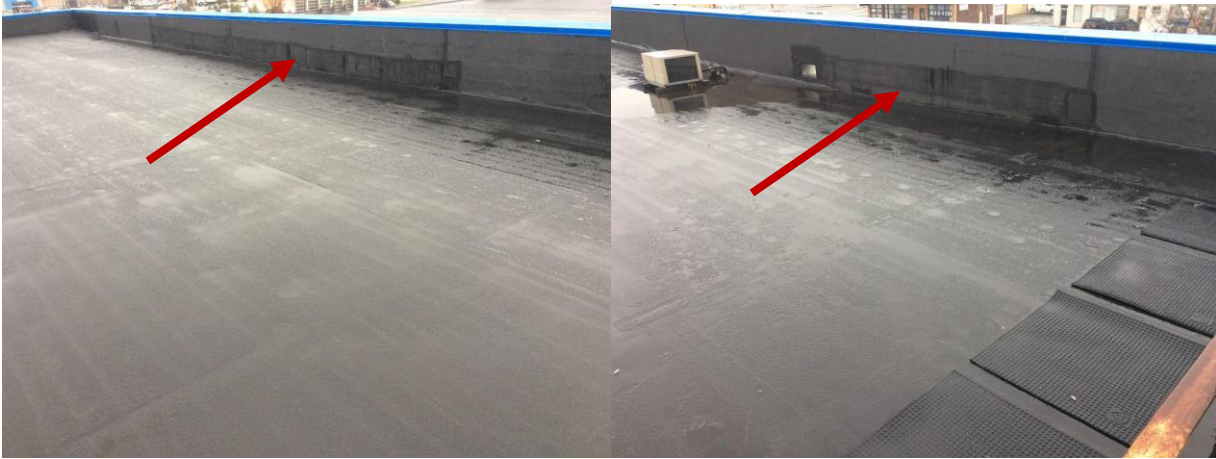
Shows side parapet wall roof repairs.

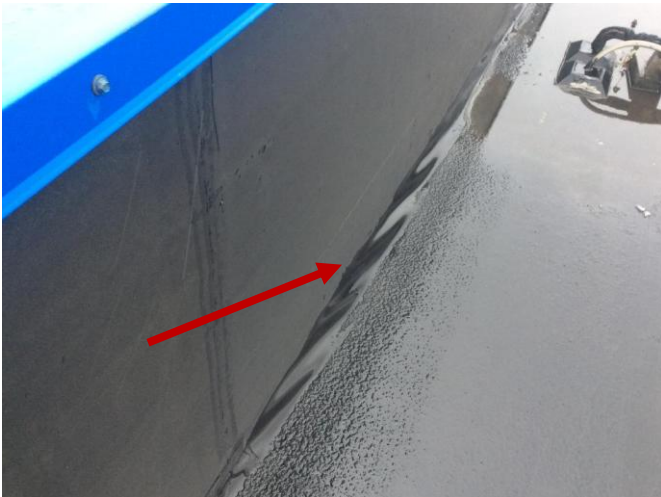
Evidence of failing roof membrane at base of parapet walls.

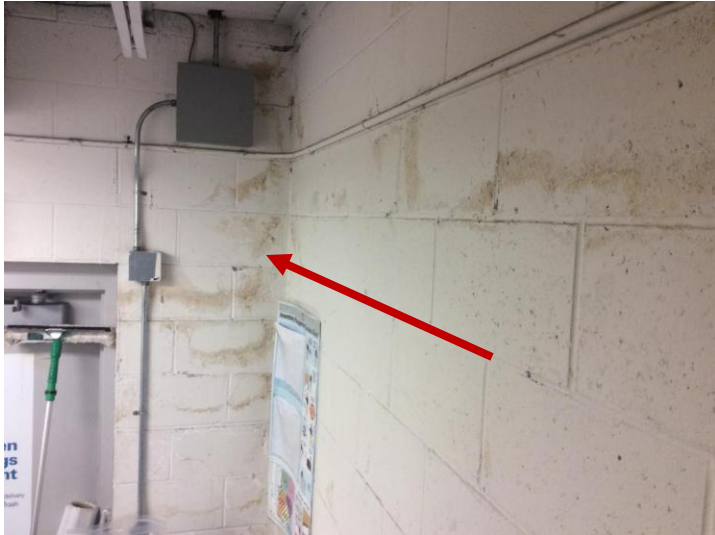
**Shows inside rear entrance wall moisture stains from previous leaks, not active during the inspection.**

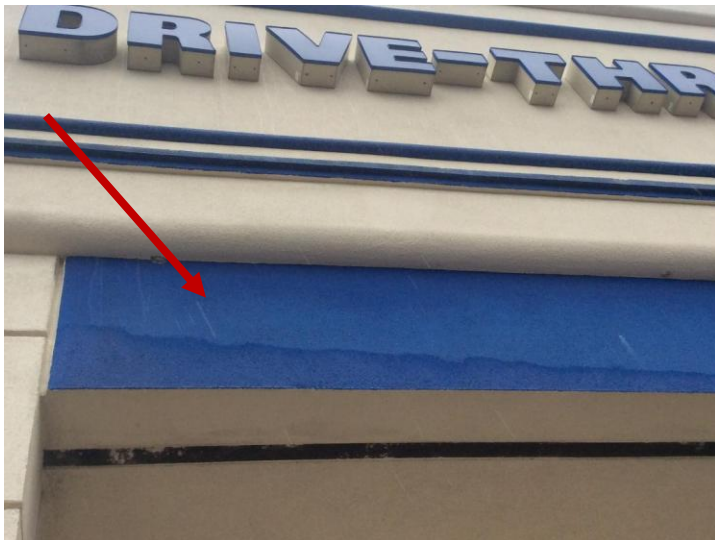
**COMMENTS:** Upper portion of building has EIFS system, Exterior insulation and finish system. Many areas of the EIFS siding is leaking and water is running down inside of the facing of the siding. Many areas have open and cracked joints that is allowing water behind the siding. Suggest further review of the leaking siding by a reputable siding contractor and repair as required. The lower part of the building is masonry block.

**Shows leaking water behind siding upper front.**

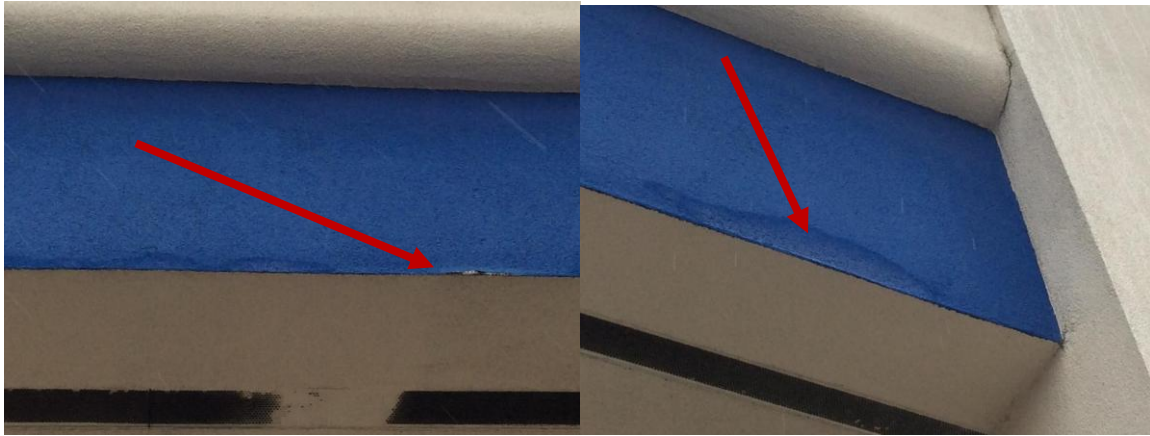
**Shows lower edge of front building siding where water is running behind the siding, repairs are required.**

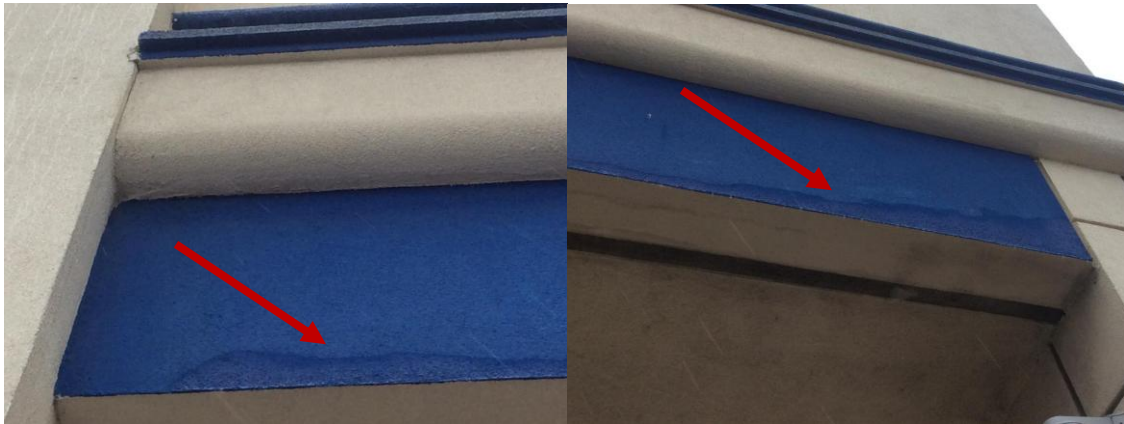
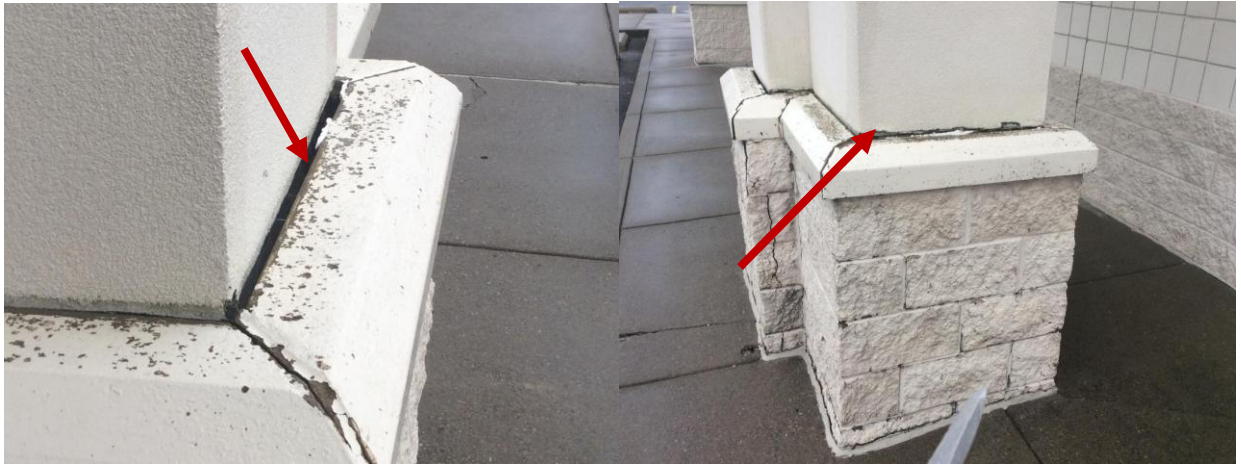
**Shows water damaged caps on columns at west side of building. All caps will need to be removed, re-set and caulked to prevent water penetration.**

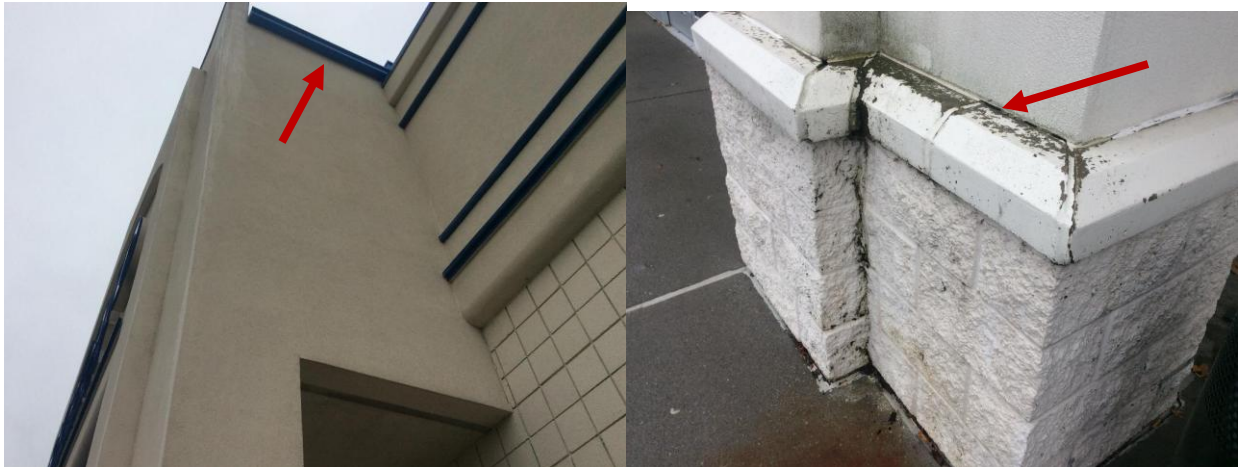
**COMMENTS: West gutter is leading at end cap and water is running down siding, repair gutter.**

**Shows leaking gutter that is running water down siding and causing water damage to pier caps below**

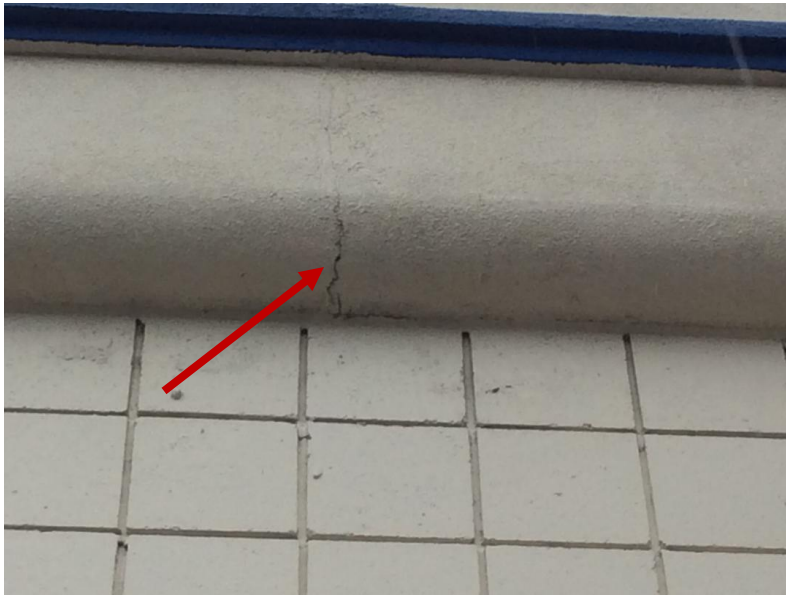
**Shows cracking siding needs repairs.**

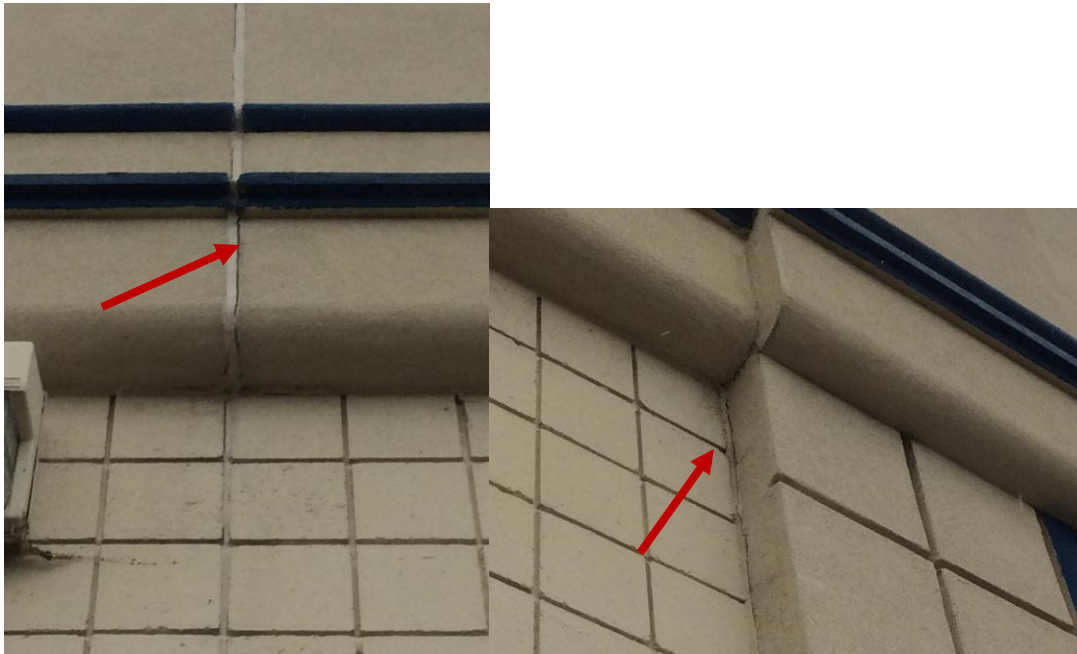
**COMMENTS:** There are many areas where the caulking is allowing water to enter behind the walls and siding. Re-caulk the building expansion joints as required.

**Shows open and failing calking joints that are in need of repairs.**

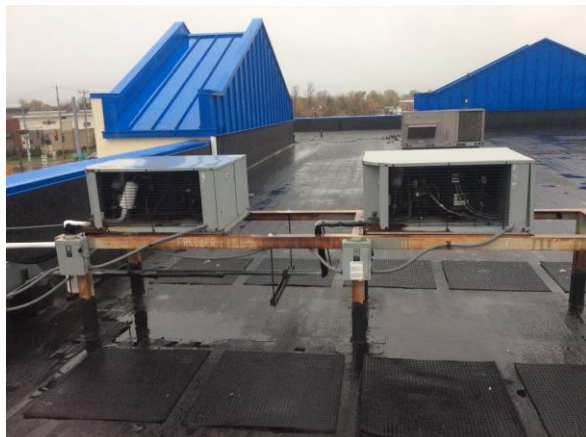
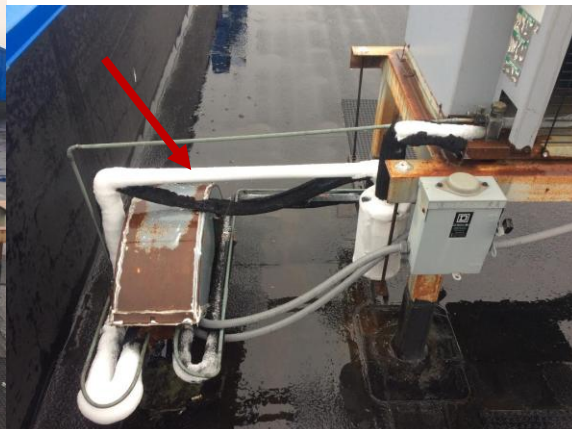
Refrigeration units, iced up are in need of new insulation

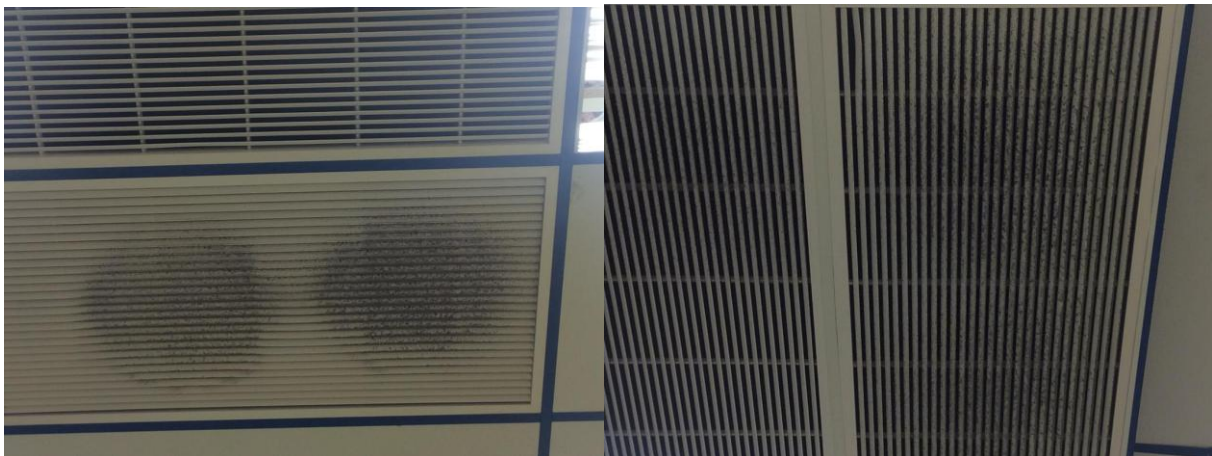
**COMMENTS: Filters are filthy and need replacing.**

**Shows inside store filters are in need of replacing.**

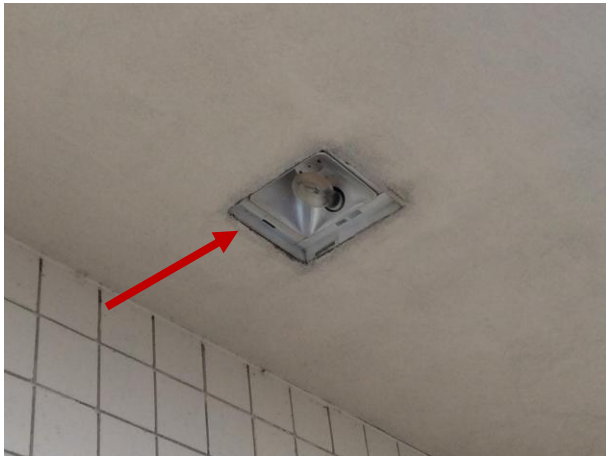
**Replace light cover west side.**

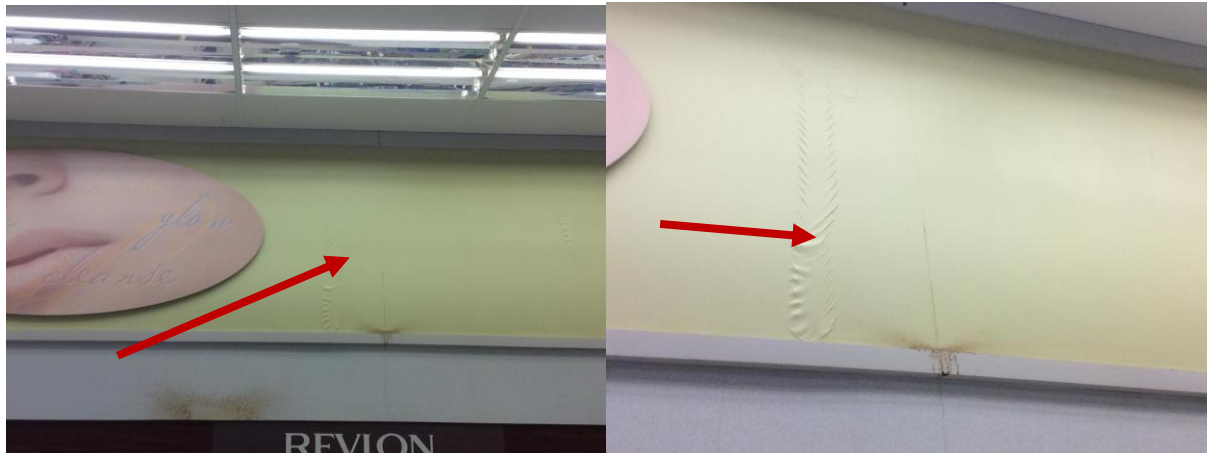
**COMMENTS: Active roof leak east side of building.**

Shows roof leaking on east side of the store active
