## BUILDING INSPECTORS OF WNY, INC.

**Re: Structural Foundation Inspection  
Buffalo NY**

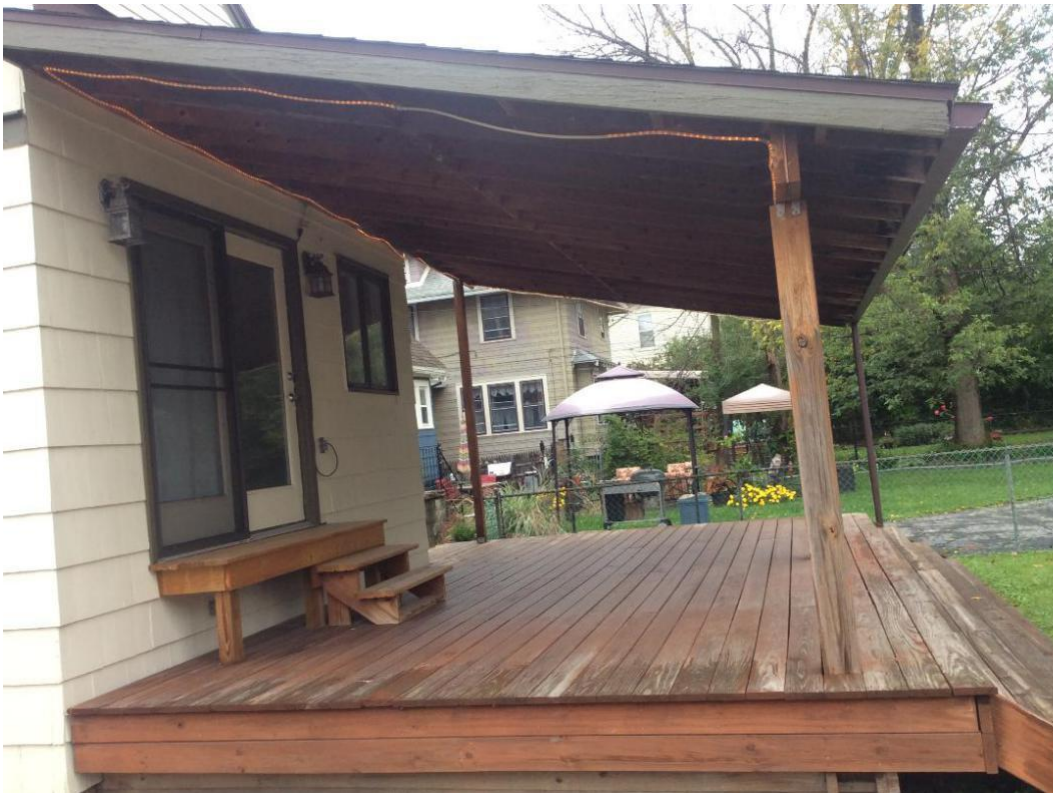
**REAR PORCH DECK ROOF STRUCTURE-** The rear covered porch roof is constructed with 2X6 rafters 16" centers with a double 2X10 header. The roof is lag bolted into the existing structure below the overhang. The support columns under the header are 6X6 supported on footings. The North West corner is supported by a single 2X8 header that is undersized and should be doubled up. The support column under the NW corner should be upsized to a 6X6 wood column with a concrete footing support. Presently the 4X4 column is resting on the deck wood structure. The end of the roof rafters should be secured to the main wood by with metal straps to prevent roof uplift.

**Shows rear covered porch roof deck.**

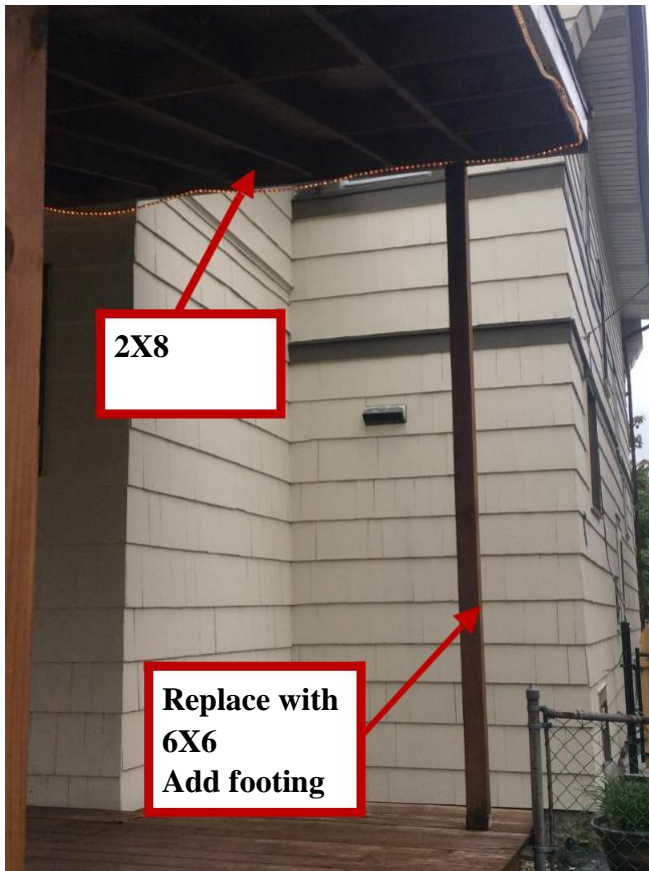
**Shows undersized 2X8 header and support column without a footing. Suggest double up 2X8 wood header and replace 4X4 column with a 6X6 column with a concrete footing.**

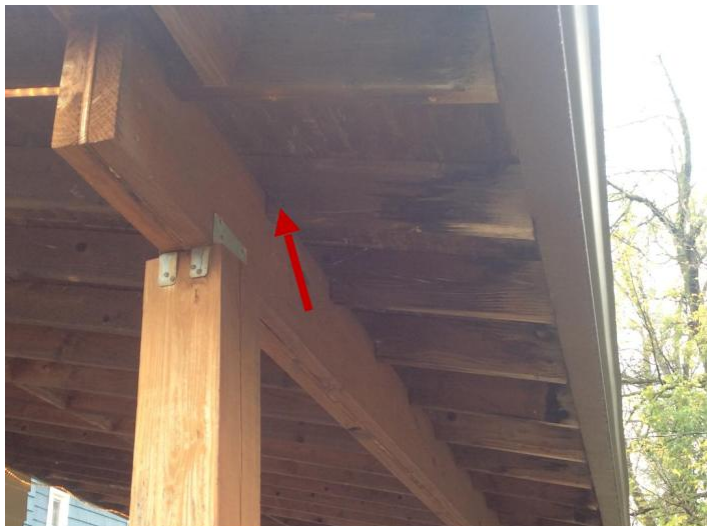
**Suggest adding metal tie down straps to secure roof rafters to wood header.**

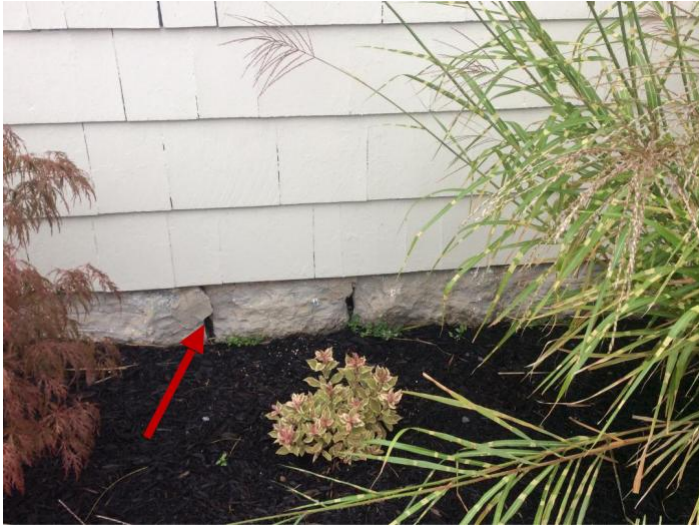
Shows open stone mortar joints at front crawl space wall, mortar any open joints.

**EXTERIOR WALL AREA-** The exterior basement walls are large stone blocks. The walls show bowing inward and settlement. The most notable bowing is along the north wall along neighbors driveway. Suggest re-pointing any open stone mortar joints.

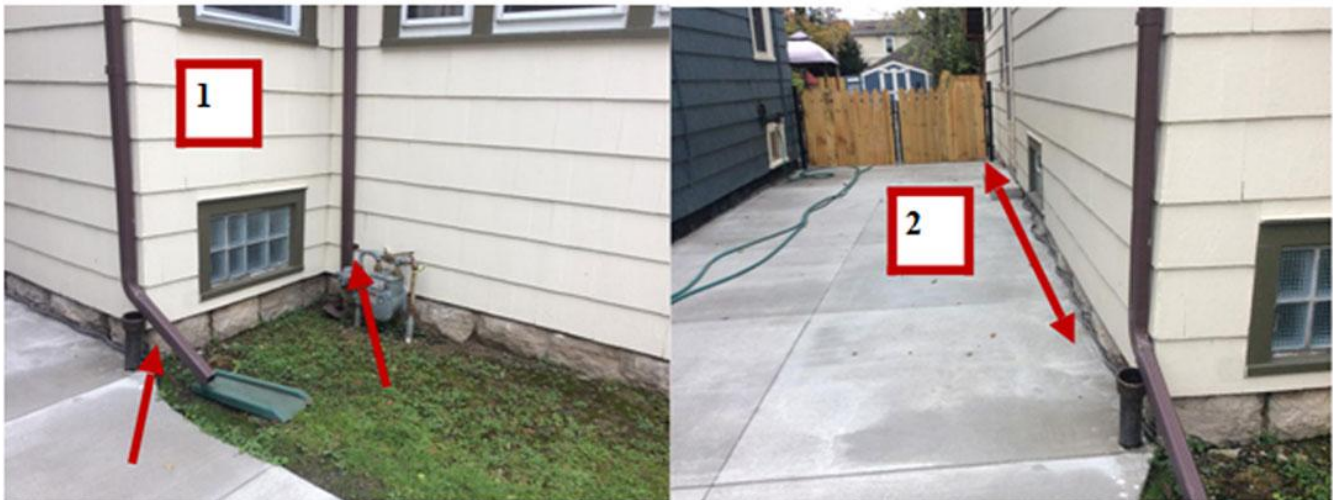
1. Shows poor drainage at base of foundation wall, improve drainage so water runs away from foundation walls.
2. Shows bowed wall along neighbors driveway

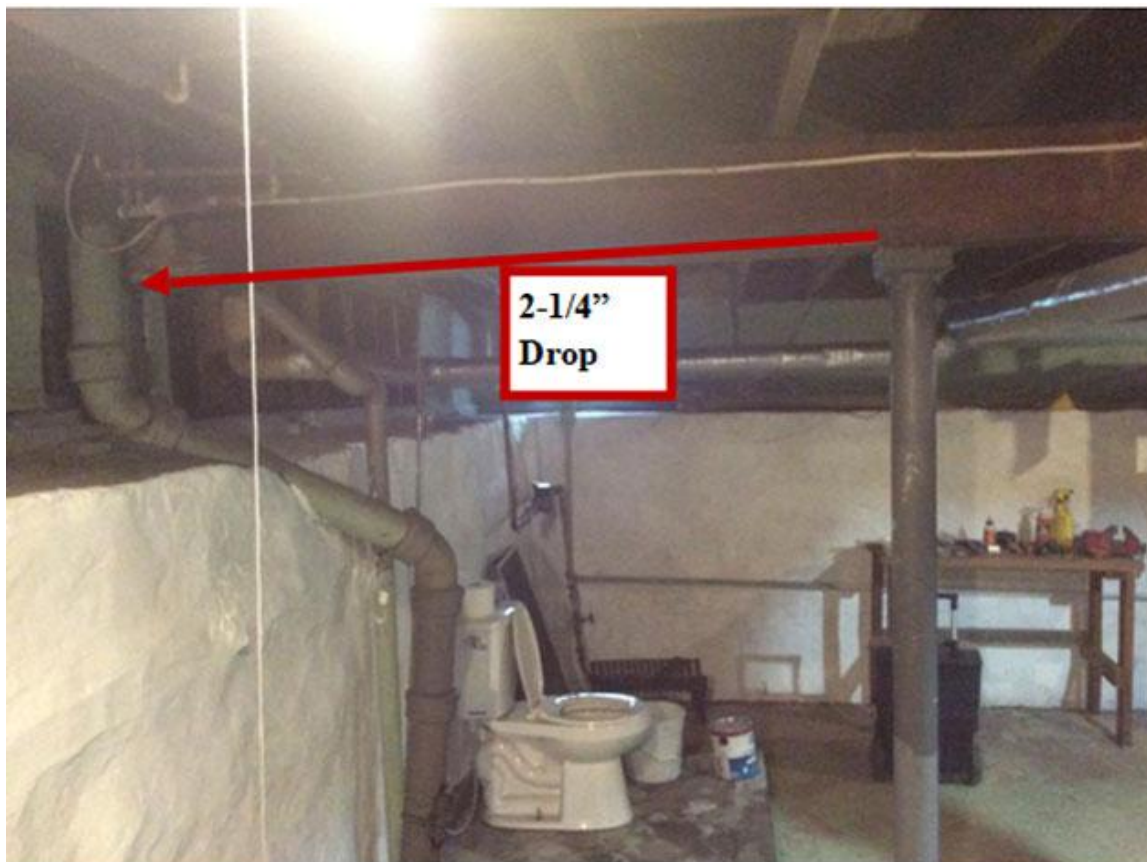
**INTERIOR BASEMENT WALLS-** The house is constructed on a full basement and a small crawl space under the front living area. The basement walls below grade are cut stone blocks. The walls have bowing inward along the sides and the walls have also settled by as much as 3-1/4" at the front corner. We set up a laser in the basement and measured the elevations at several location along the main support beam and foundation (see attached sketch). The foundation walls have settled from 1-3/4" to 3-1/4" as measured from the main center support beam. This foundation settlement has caused the floors to become out of level through the house. The stone walls likely do not have concrete footings below the stones and poor drainage loosens up the soils below the walls and causes settlement. It's important that the exterior drainage be managed so water flows away from the foundation walls. It is not possible to determine if the walls will continue to settle in the future from a visual inspection. Future monitoring of the walls will be required to determine if future movement is or is not occurring. We did not notice any recent major wall or ceiling cracking in the living areas which would indicate no evidence of recent settlement.

**Shows bowing of South wall along with wall settlement of the wall. Note main wood beam is sloping down towards the foundation wall from the wall settlement.**

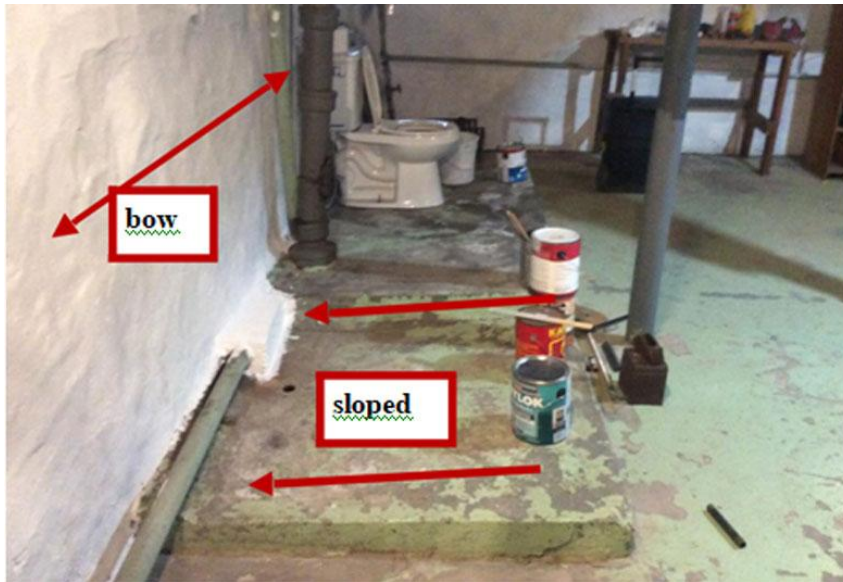
Shows bowing of south wall and slab concrete pad sloped towards wall from settlement.

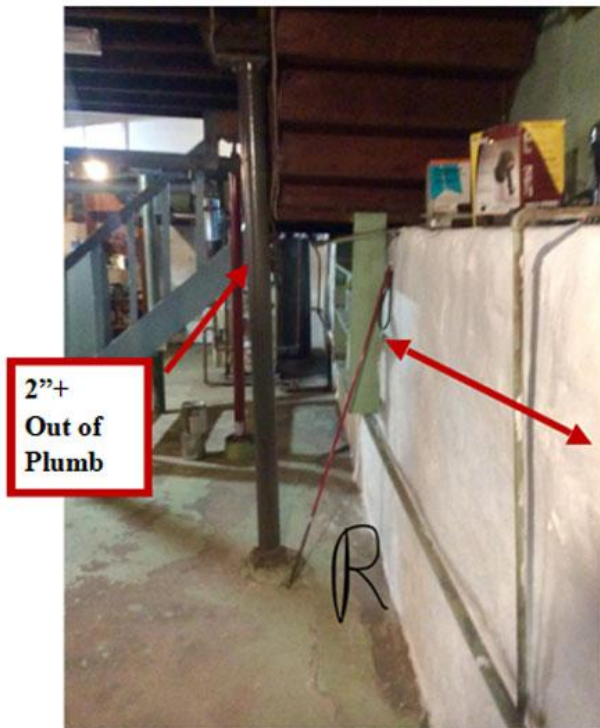
Shows north wall bow inward and steel column out of plumb by 2" + from wall movement pushing stairs.

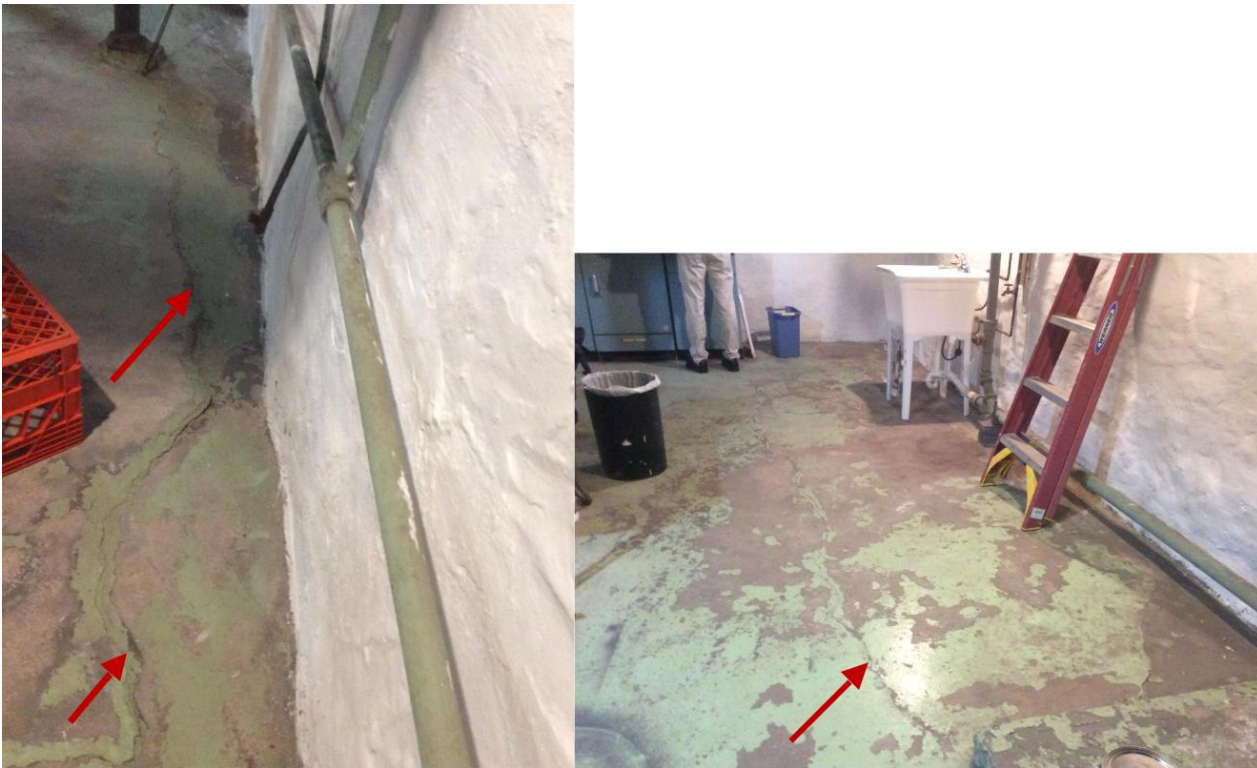
Shows cracked concrete floor along walls indications of wall settlement.

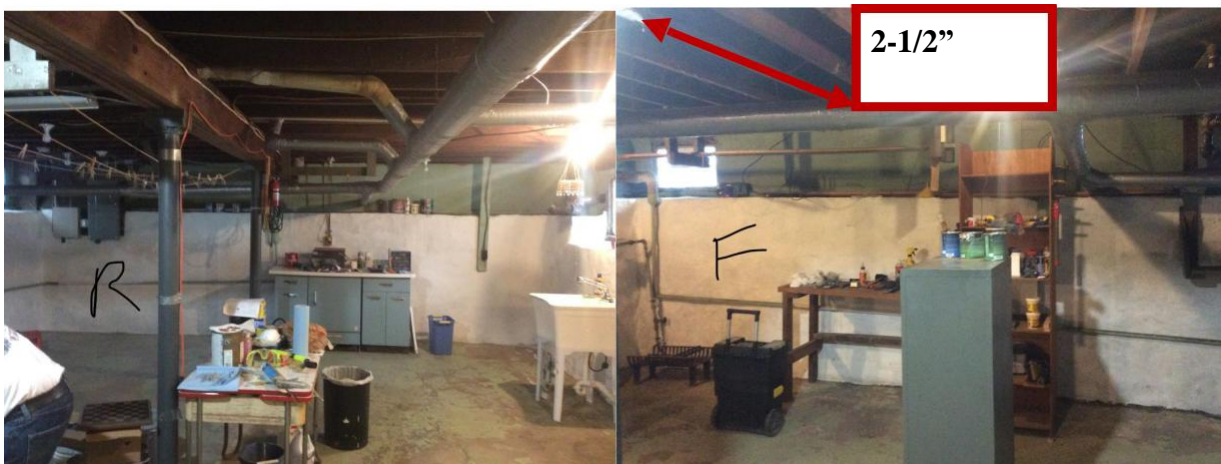
Shows rear and front walls for reference. Note front wall is lower than main wood support beam by 2-1/2".

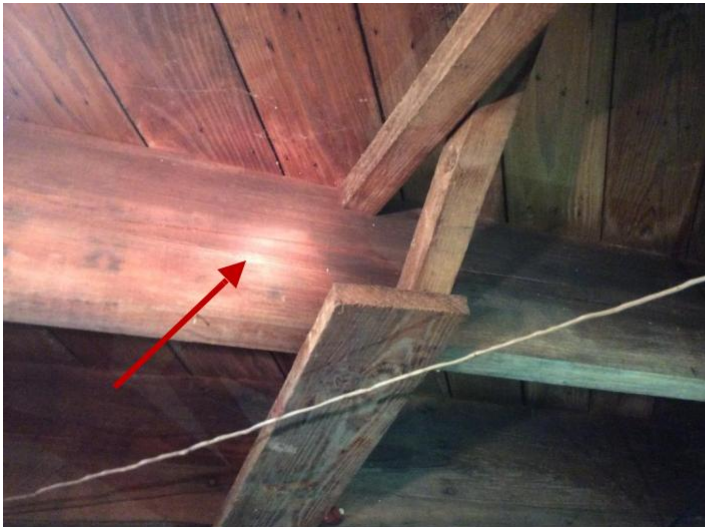
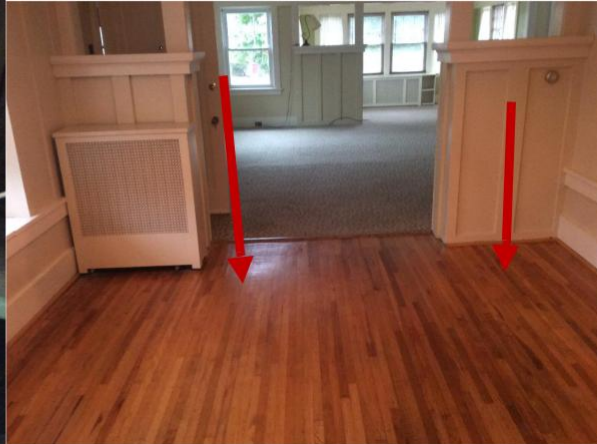
**Shows split floor joists under living/dining room header wall. Add additional support to split basement floor joists as required to firm up floor under header wall.**

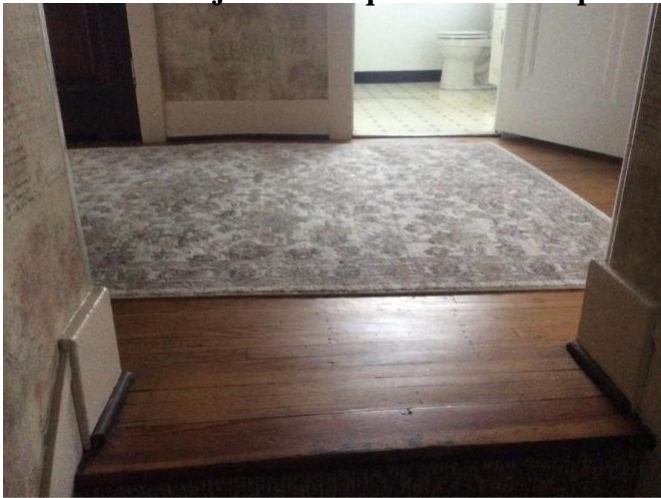
**Shows out of level 2<sup>nd</sup> floor hall area from settlement and bowing floor framing not supported properly down to basement.**

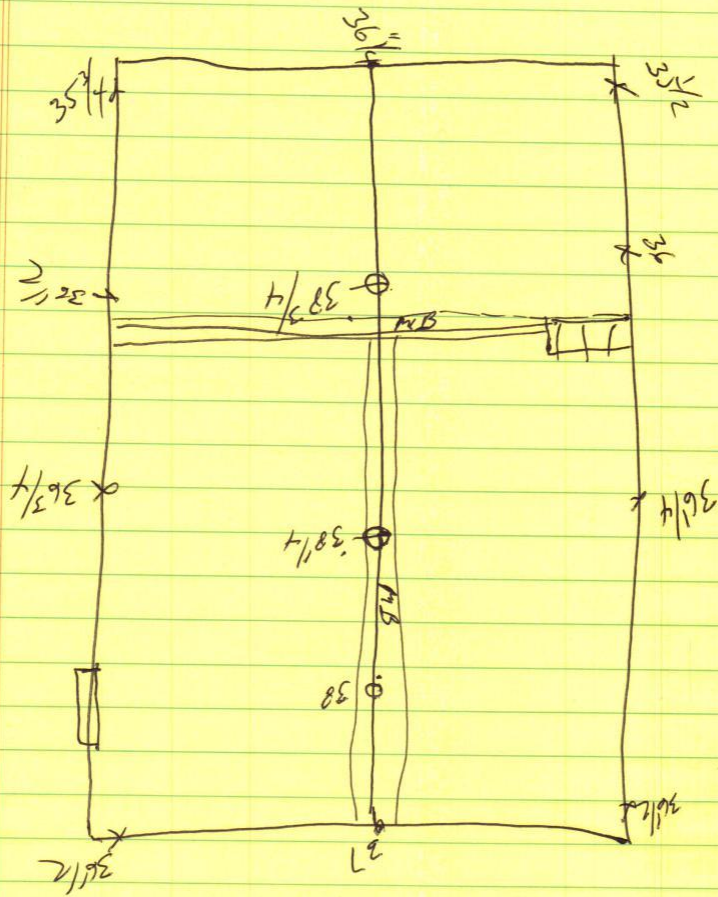
Front

Elevations measured with LASER  
IN BASEMENT RANGE  $38\frac{3}{4}$ " TO  $35\frac{1}{2}$ "  
INDICATING  $3\frac{1}{4}$ " FOUNDATION DROP AT  
FRONT CORNER.
